## **SERVICE BULLETIN SB/EUR/009 ISSUE 1**

### **EV-97 teamEurostar UK AIRCRAFT**

## **INSPECTION OF UNDERCARRIAGE LEG SUPPORT FOR CRACKS**

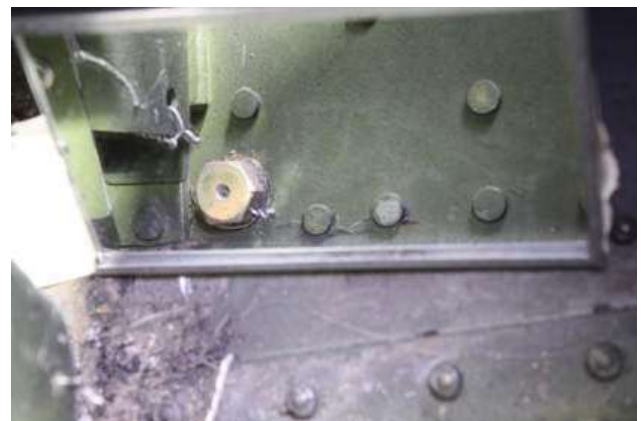
On a number of high hour EV-97's, cracks have been detected in the outboard end of the vertical support to the undercarriage leg. The cracks so far detected occur between the hole for the bolt securing the leg to the cross member, and adjacent inboard two rivets. To date cracks have been found on only the rear plates.

The crack can be seen in the photo on the right evidenced by the horizontal line emanating from beneath the bolt head. Rear of right hand plate shown, the photo is taken through a mirror.

Continued propagation of the crack reduces the undercarriage strength and ultimately could lead to complete failure of the leg attachment during landing or taxiing.

A repair scheme design is currently being prepared. Its form will, to some extent, depend on the nature of the reported cracks.
