COSMIK AVIATION

4th November 2004

SERVICE BULLETIN SB/EUR/001 ISSUE 1 **EV-97 teamEUROSTAR UK AIRCRAFT** **COOLANT OVERFLOW BOTTLE**

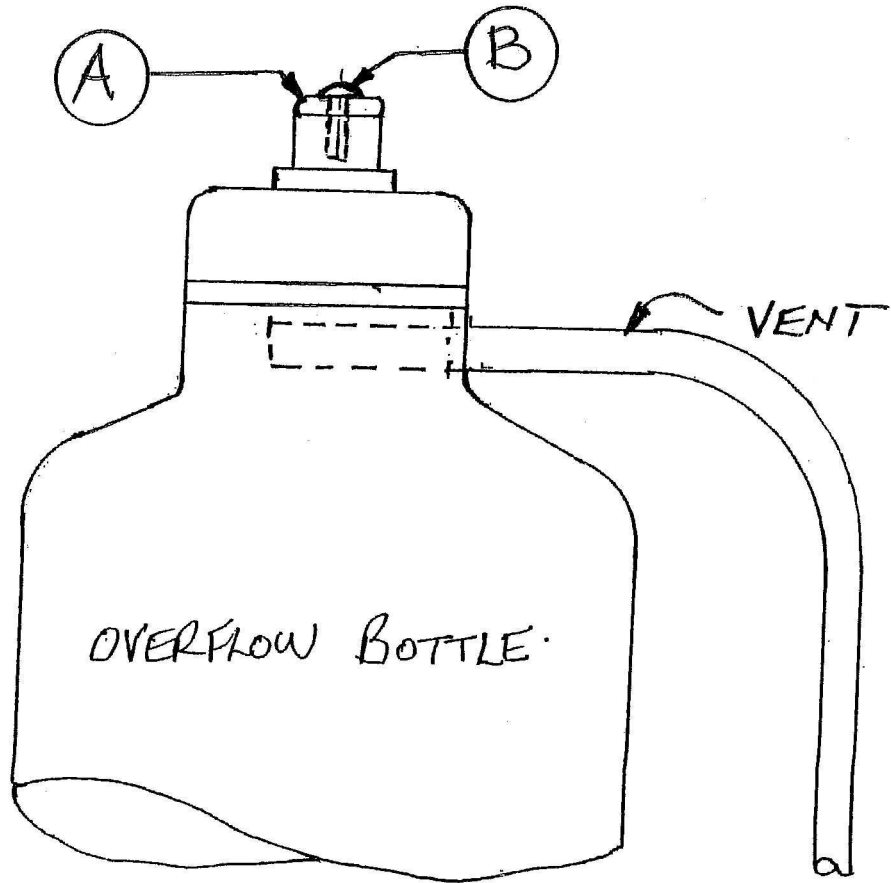
FIG 1.

The plastic overflow bottle fitted on the firewall has a flexible vent hose fitted near its top to route steam and coolant outside the engine compartment, in the very unlikely event of the coolant boiling (see Fig.1). The top of the bottle should be completely sealed with a push button valve (A), but we have noticed that in some cases Aerotechnik have drilled through the valve to make a permanent vent on the top. This of course gives two vents, and would allow some coolant to discharge into the engine compartment in the event of boiling.

Because of the very efficient cooling system on the teamEurostar, boiling is extremely unlikely unless the radiator has been blanked off in the winter and forgotten. In the event of boiling, with an open vent at the top, some coolant may spray into the engine compartment, and some may possibly be drawn into the carburettors, causing a misfire.

Remove engine top cowling, referring to Fig 1. Fit a 3.2mm x 7.9mm pop rivet (B) into the small hole at the top of the overflow bottle (rivet supplied free of charge with this bulletin). Set the rivet using an appropriately sized pop rivet tool, whilst pressing down on the valve top (A). This should completely and permanently seal the top vent.

Any owners who do not have a tool to set the pop rivet, can obtain a modified exchange bottle cap from Cosmik Aviation, free of charge.
