12th August 2007

SERVICE BULLETIN SB/EUR/OO2 ISSUE 1
EV-97 teamEUROSTAR UK AIRCRAFT
TRIM CABLE CLEVIS PIN RETAINER

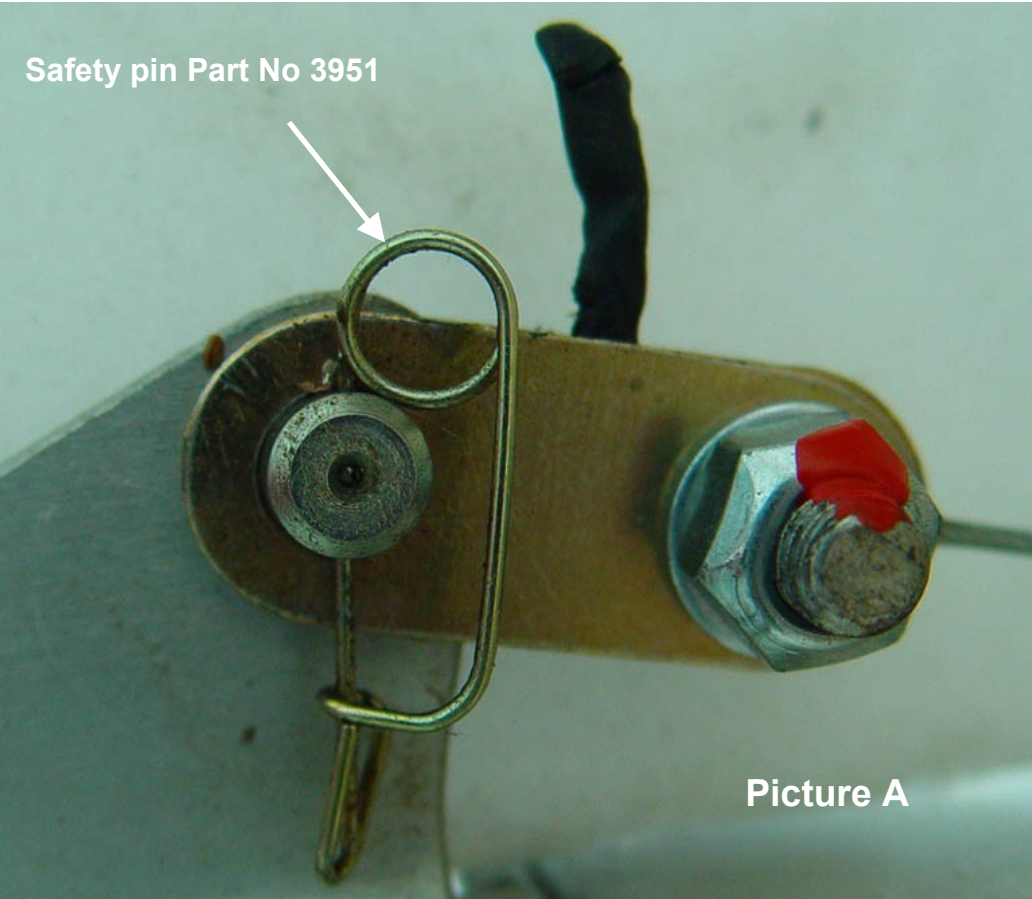
There is a possibility that during cleaning, handling or fitting/removing aircraft covers the safety pin, part No 3951, retaining the trim cable clevis pin to the trim tab horn could become unclipped and fall out. (See picture A)

A normal pre flight inspection should cover this area, but if missed and the safety pin were to fall out and subsequently allow the clevis pin to fall out, loss of the elevator trim control would result.

Remove the safety pin, part No 3951, from the top trim cable clevis pin (picture A) and replace with split pin 2 X14, (part No 3188 available from Cosmik) as per picture B. Bend the ends of the split pin as in the picture to secure the split pin and prevent them being caught by cleaning rags, aircraft covers, ETC.
Repeat the above procedure for the lower trim cable clevis pin.
