## **UK BUILT EV-97 EUROSTAR AIRCRAFT**

### **SERVICE BULLETIN, SB EV97-UK-01.**

Attachment of Flap Control Rod to Flap Control Lever. (see fig.1 accompanying this bulletin)

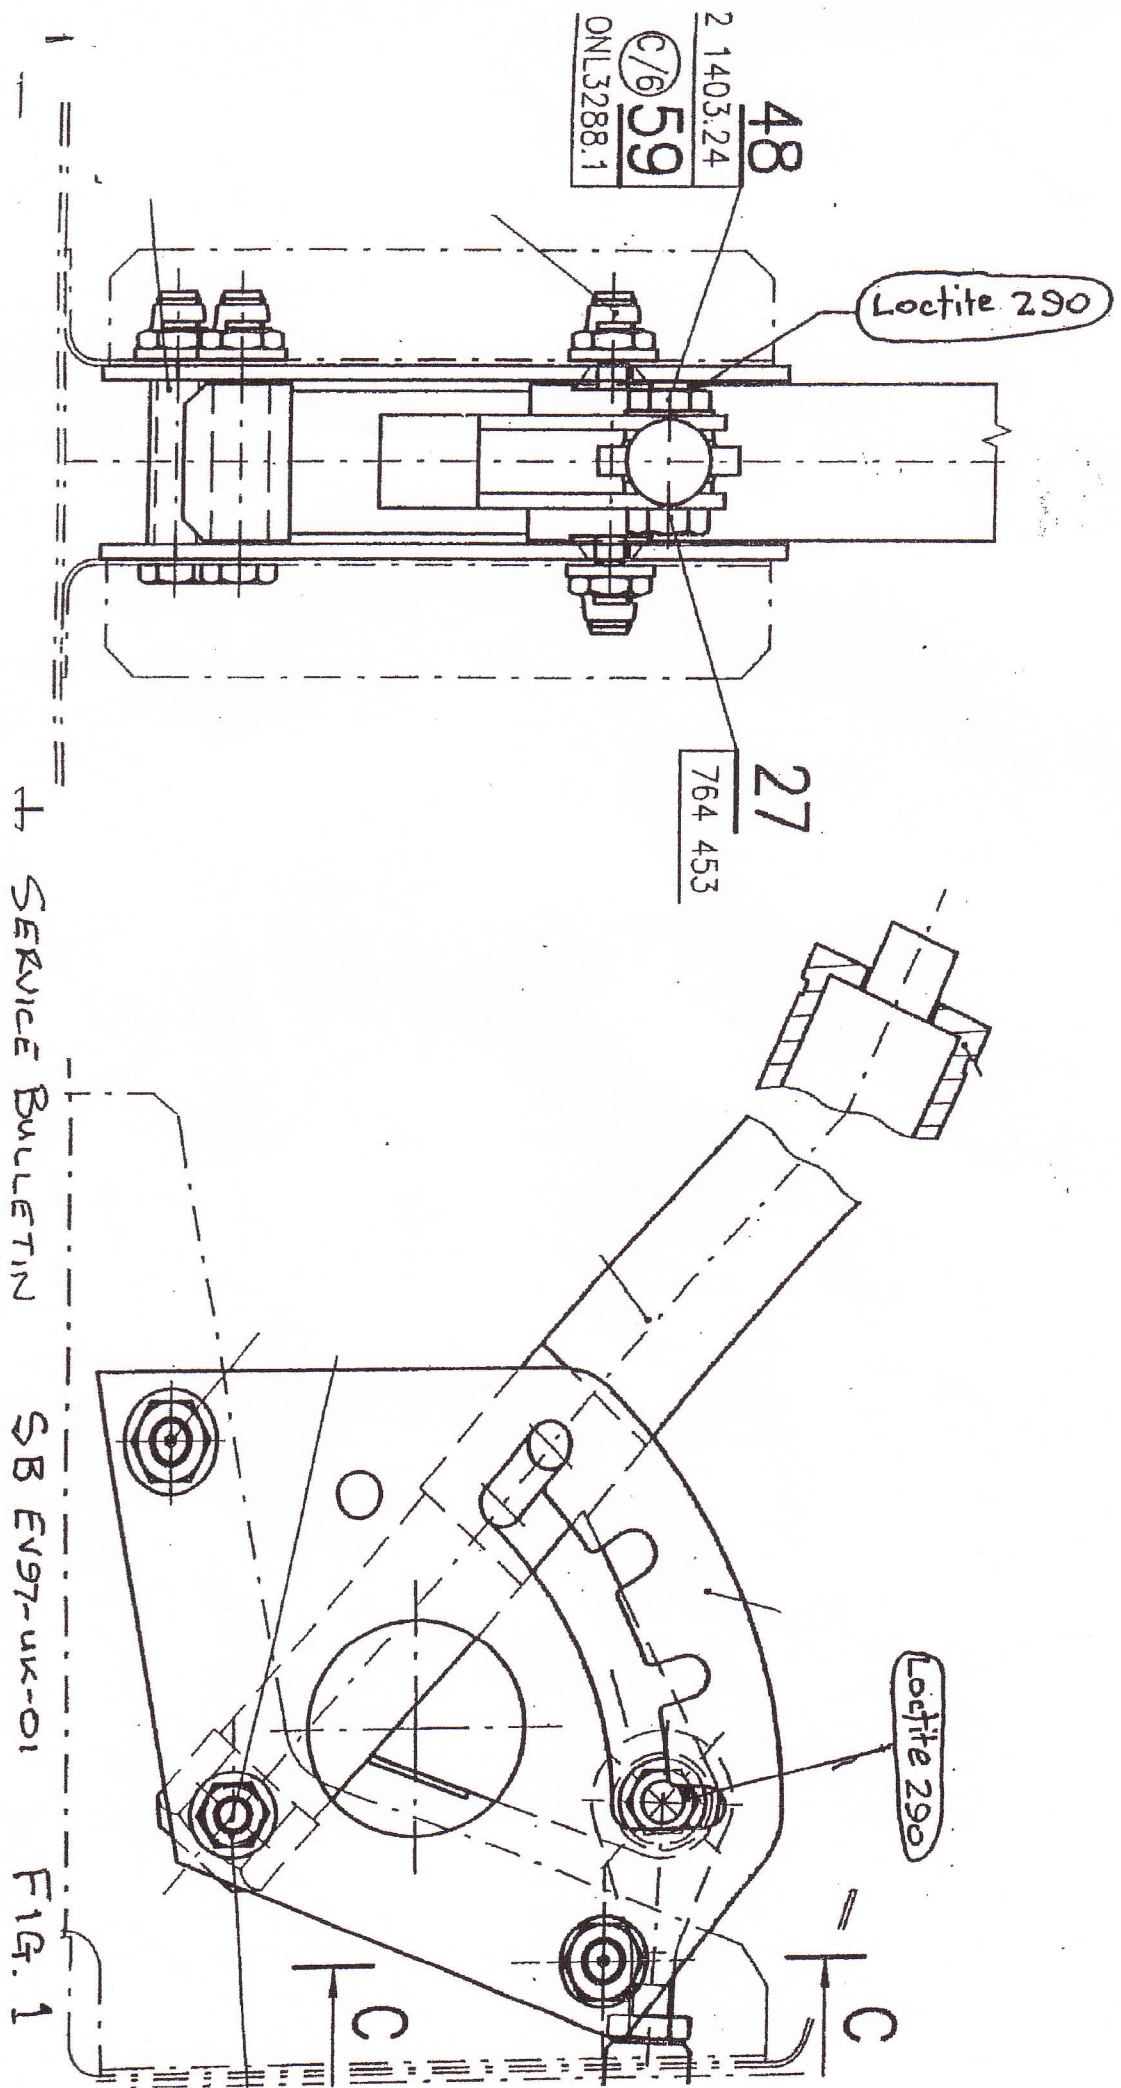
SERVICE BULLETIN SB EV97-UK-01 FIG. 1

It has become apparent that, due to unclear build instructions and drawings, some aircraft may have been built with inadequate locking of the attachment bolt and nut at this position. (items 27, 48&59 on fig.1)

Aerotechnik has confirmed that the nut, (item 48) and the bolt, (item 27) should be locked with a tab washer, (item 59) even though fig .1 only shows the nut being locked.

Because of poor accessibility, it has been agreed with PFA Engineering that on completed aircraft Loctite 290 may be used to provide joint security rather than an additional tab washer.

Check that items 48& 27 are still tight.

Apply one drop of Loctite 290 to the protruding end of the bolt at the position indicated on fig 1.
