## **SERVICE BULLETIN SB-EV97-UK-015 Issue 1**

### **Kit Built Eurostar AIRCRAFT**

## **INSPECTION OF UNDERCARRIAGE LEG SUPPORT FOR CRACKS**

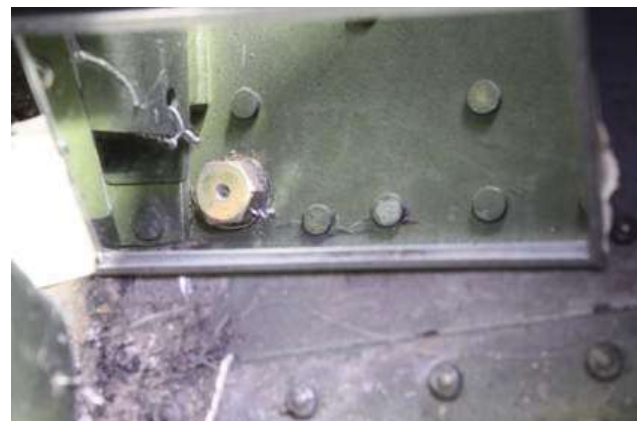
On a number of high hour EV-97's, cracks have been detected in the outboard end of the vertical support to the undercarriage leg. The cracks so far detected occur between the hole for the bolt securing the leg to the cross member, and adjacent inboard two rivets. To date cracks have been found on only the rear plates.

The crack can be seen in the photo on the right evidenced by the horizontal line emanating from beneath the bolt head. Rear of right hand plate shown, the photo is taken through a mirror.

Continued propagation of the crack reduces the undercarriage strength and ultimately could lead to complete failure of the leg attachment during landing or taxiing.

A repair scheme design is currently being prepared. Its form will, to some extent, depend on the nature of the reported cracks.
